PROPERTY INSPECTION REPORT

Date: 8/26/2022

Prepared For
Happy Client

1234 Sample Way, Virginia Beach

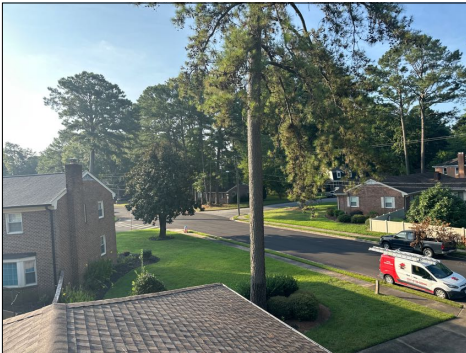
2.2. All trees limbs should be trimmed back to prevent damage and wear to roof.

Should be trimmed back

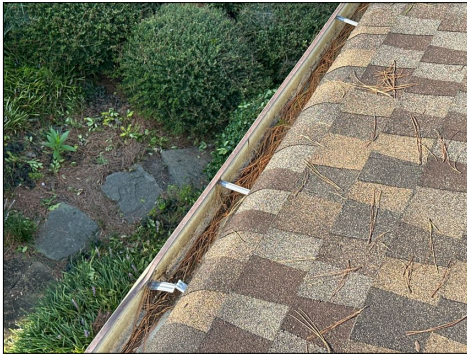
3.2. All debris should be removed to allow proper drainage and prevent damage to gutters or moisture damage to structure.

Clear all debris from gutters

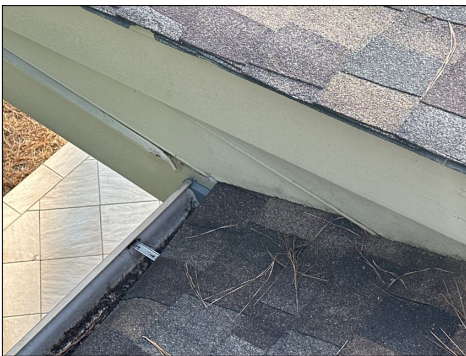
4.1. **Kick-out flashing(s)** at roof to wall intersections were missing, although no issues were observed we cannot see the underlying material. It is recommended they be installed to prevent moisture intrusion.

Missing kickout **flashing**

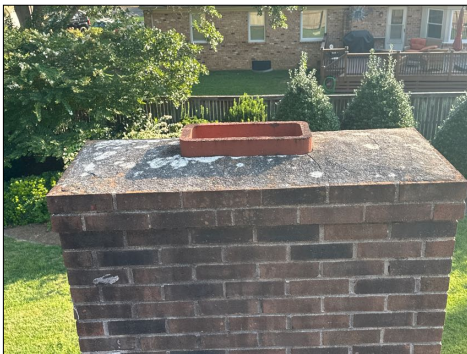
5.1. A rain cap/spark arrestor is recommended to prevent embers from exiting as well as wildlife and moisture intrusion.

No spark arrestor/ rain cap

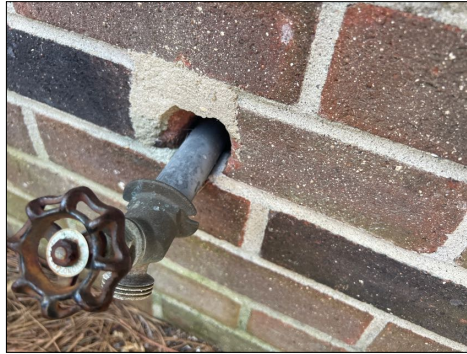
- 1.1. Sealant maintenance was needed at penetrations and lights of the exterior cladding.

Recommend sealing all penetrations

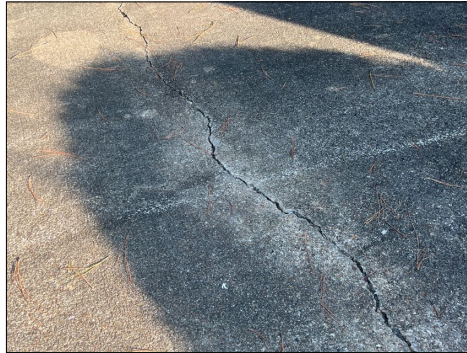
- 2.1. Normal cracking was present with no significant deficiencies.

Cracked concrete

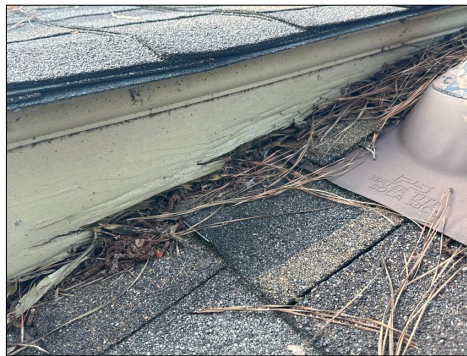
- 3.1. Damaged wood trim was observed, the cause should be determined, and all necessary repairs made. Location:left rear

Damaged wood

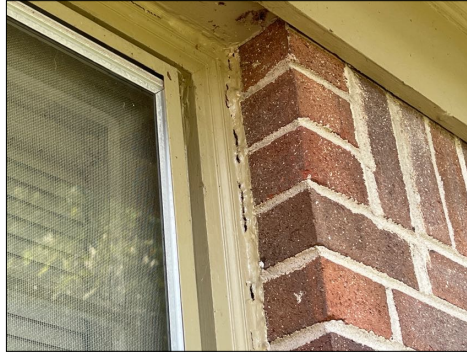
- 5.1. Sealant maintenance was needed at window(s) to prevent moisture intrusion. Location: multiple windows

Sealant needs repair

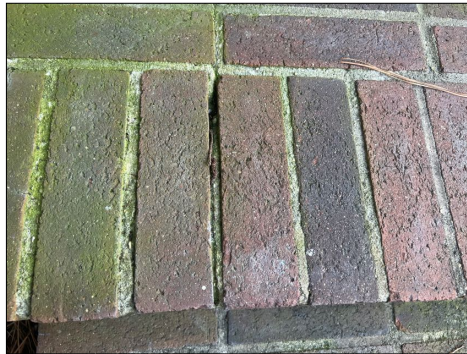
6.1. Mortar repair was needed at the brick stairs to prevent unsafe conditions. Location: front steps

Mortar needs repointing

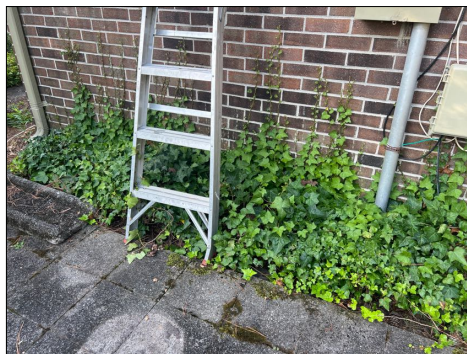
8.1. **Vegetation** growing against the exterior walls should be removed or trimmed back to protect structure and foundation.

Vegetation should be trimmed back

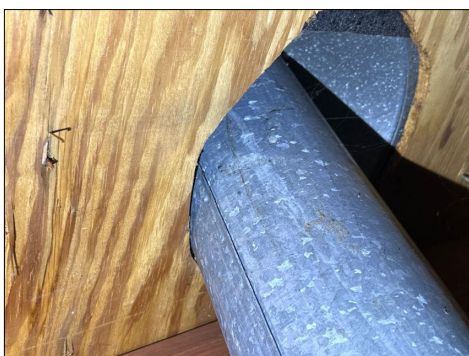
4.1. Inadequate clearance to combustible material for the heating system vent should be corrected. Location: right side attic

Inadequate vent clearance

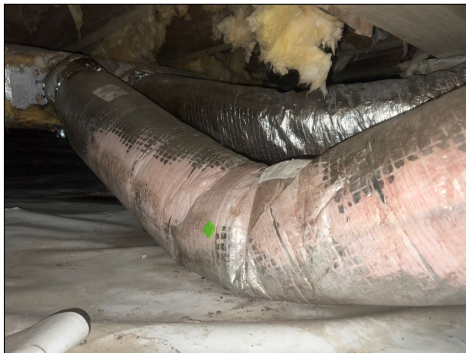
9.2. Duct work on the crawlspace floor can allow damage from moisture and should be properly supported and any damaged sections be replaced.

Unsupported ductwork

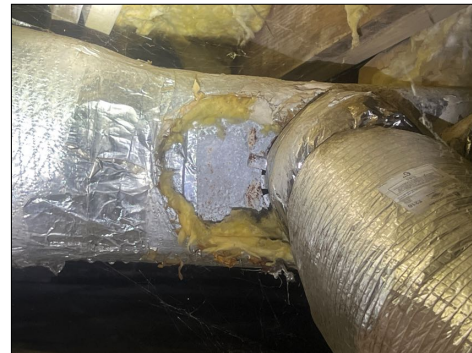
9.3. Damaged or loose duct work insulation in the crawlspace should be repaired. Location: middle crawl

Insulation damaged at ductwork

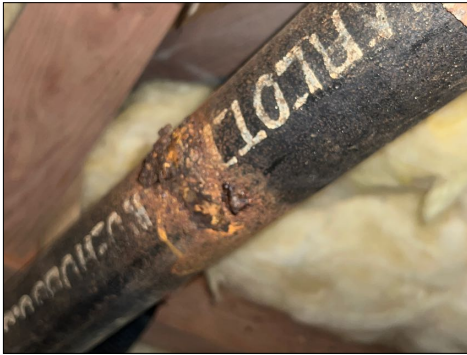
4.4. Corrosion and signs of previously leaking at the cast iron drain line should be evaluated by a qualified plumbing contractor for repair or replacement of damaged areas.

Corrosion at cast iron drain line

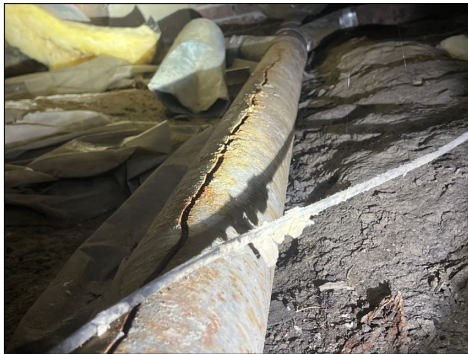
4.5. Damaged waste lines in the crawlspace create unhealthy conditions and should be replaced. Location: rear right

Damaged/Cracked drain line

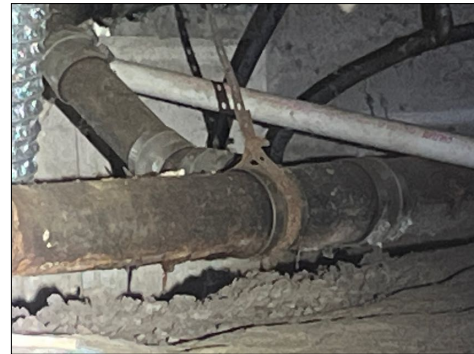
4.2. Leaking drain line(s) should have all necessary repairs made. Location: rear right crawl

Leaking at drain line

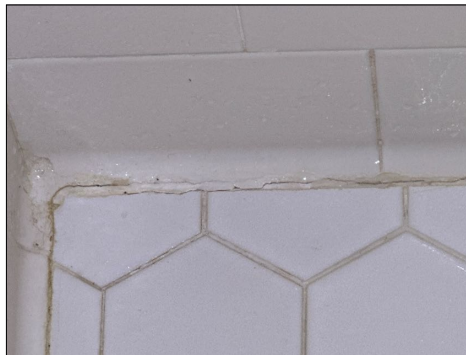
11.1. Cracked shower pan tile grout should be repaired as needed. Location: master bathroom

Grout maintenance needed

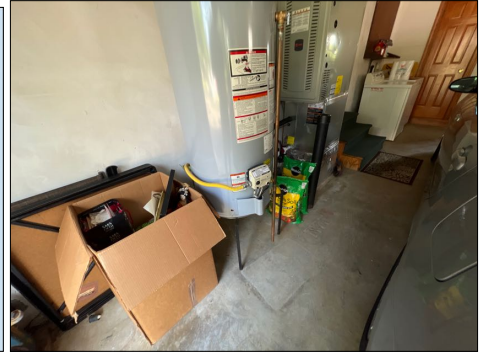
Bollard or protection needed

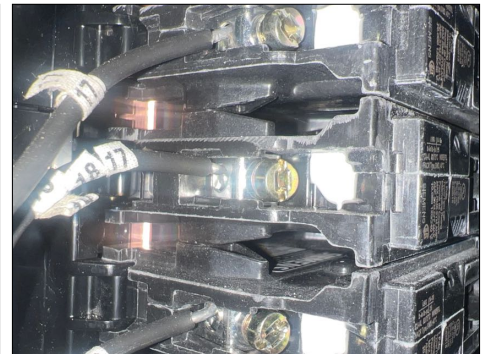
3.2. There was aluminum wiring inside the service panel that lacked antioxidant on the wiring. This indicates that the equipment has not received regularly scheduled maintenance. A qualified and licensed electrical contractor should evaluate the panel and perform service on all aluminum wiring.

Missing paste

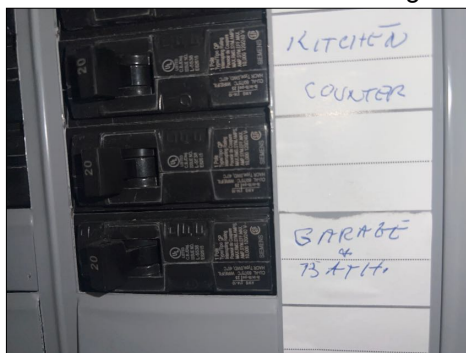
Inadequate labeling

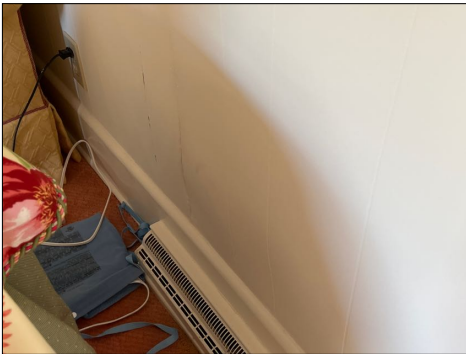
- 4.1. Damaged interior walls should be repaired as needed. Location: rear middle living area left wall
- 4.2. A full inspection of the interior walls and ceilings was limited by storage and/or personal belongings. The limitations are documented in the Limitations section.
- 4.3. FYI: **Moisture stains** on the ceiling(s) were dry when tested with a moisture meter. We recommend asking the seller if action regarding any previous issues has taken place, and if issue is resolved. The interior condition of the ceiling is unknown. Location: front right living area

Damage to walls

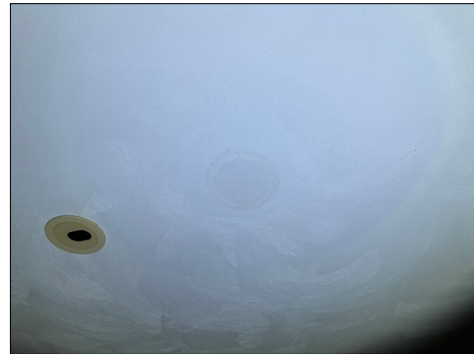
Moisture stains - dry

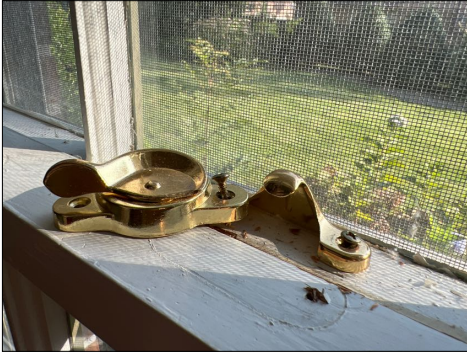
Broken lock

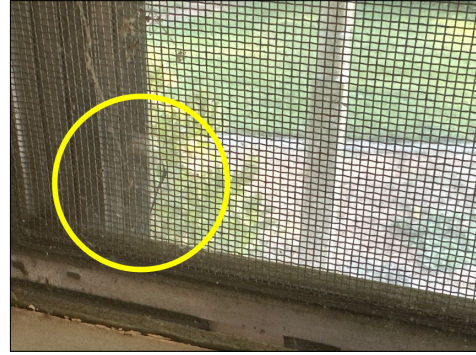
Cracked window

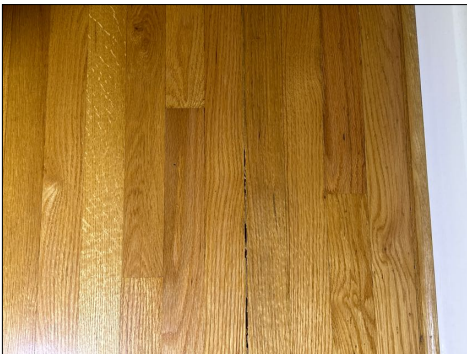
6.1. There were gaps observed in the flooring, recommend repair by a qualified contractor as needed. Location:hallway

Gaps in flooring

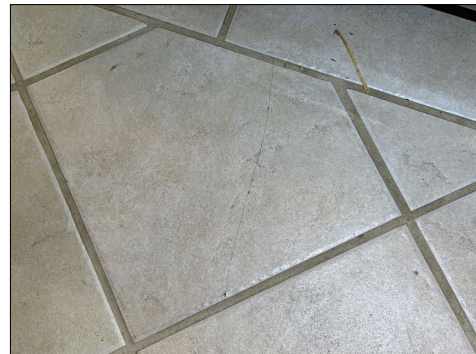
6.2. Floor tiles in an area in proximity to a water source were cracked. A qualified contractor should determine cause and repair as needed. Location:kitchen

Cracked tiles

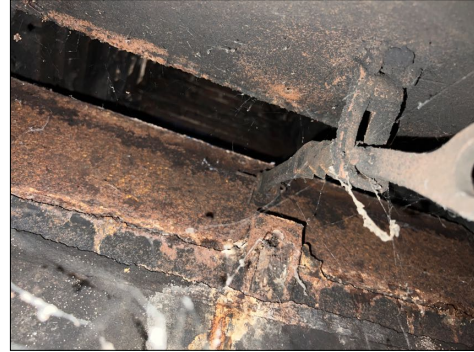
Rust and corrosion/Dirty flue

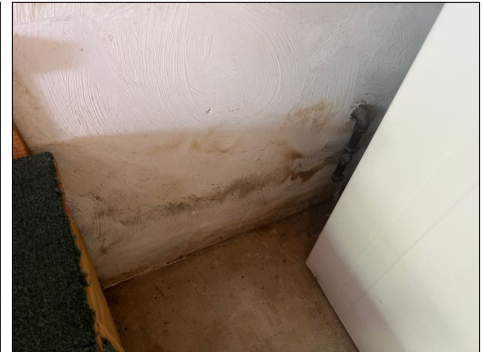
Moisture stains — dry

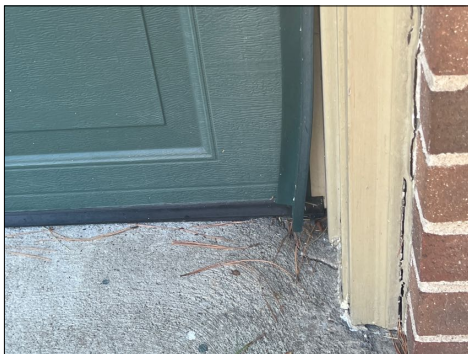
Weatherstripping needs repair

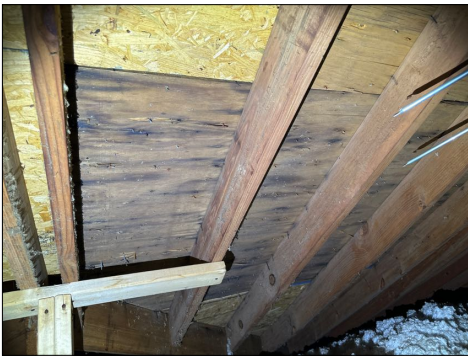
Moisture staining - evaluated dry

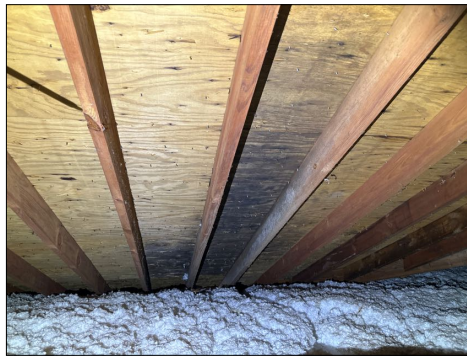
Moisture staining - evaluated dry

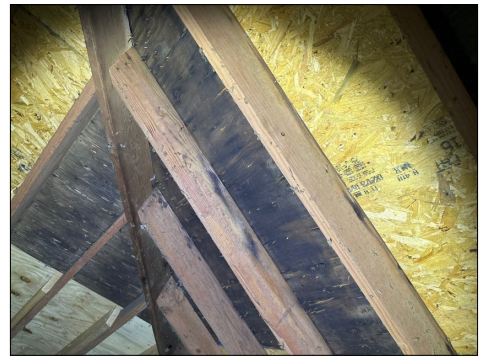
Moisture staining - evaluated dry

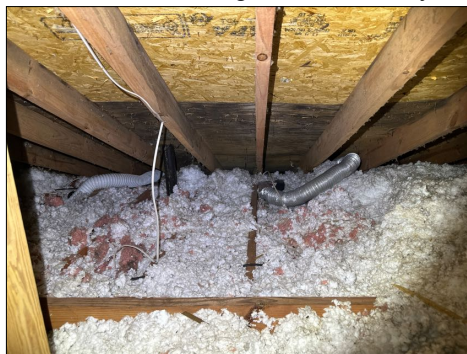
3.2. Bathroom exhaust fans vented at the soffits. It could not be determined if the soffits were open at the vent termination to allow ventilation.

Venting at soffit

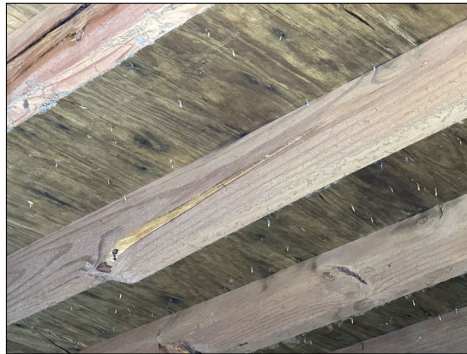
6.2. Cracked rafter(s) need repair by a qualified contractor. Location: front left

Cracked rafter

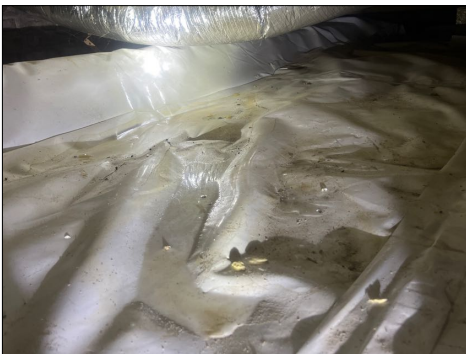
Standing water

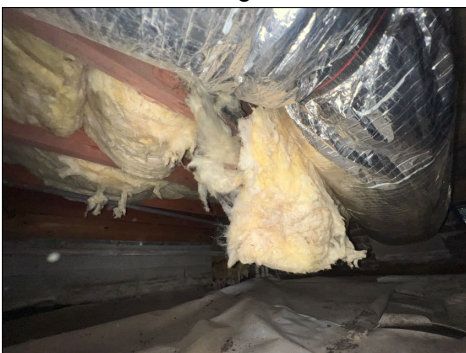
Damaged insulation

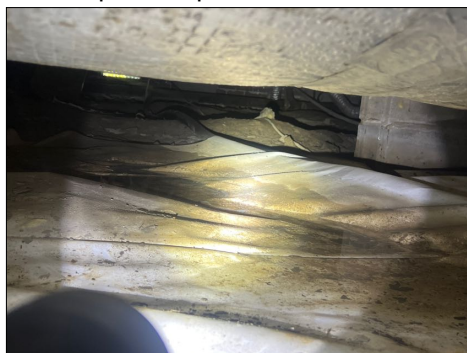
Standing water

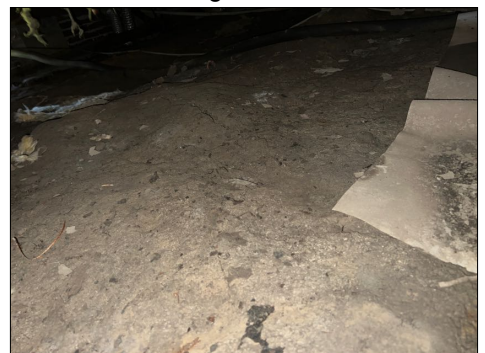
Inadequate vapor barrier installed

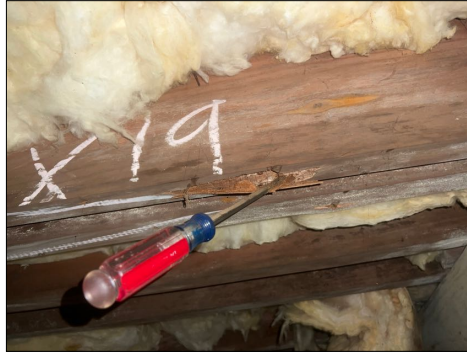
4.1. All wood damaged by **microbial growth** should be evaluated by a professional moisture inspection company to remediate as needed. Mainly located at: multiple locations

Wood damage due to **moldgrowth**

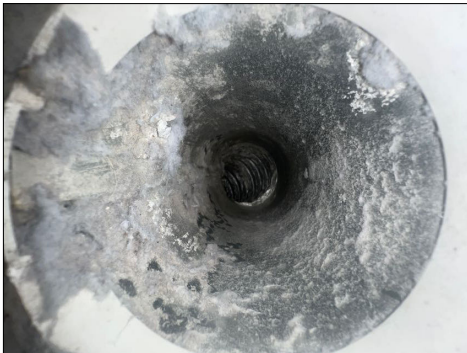
Duct needs cleaning

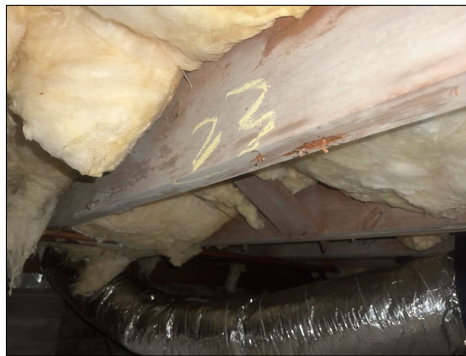
Microbial growth observed
