PROPERTY INSPECTION REPORT

Date: 8/26/2022

Prepared For
Happy Client

1234 Sample Way, Virginia Beach

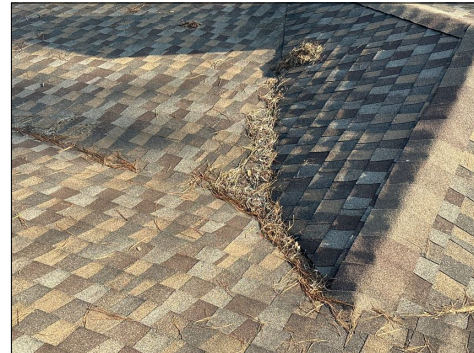
2.1. Debris on the roof should be cleared to prevent moisture issues and premature wear. We cannot determine condition of roof under the debris.

Clear debris

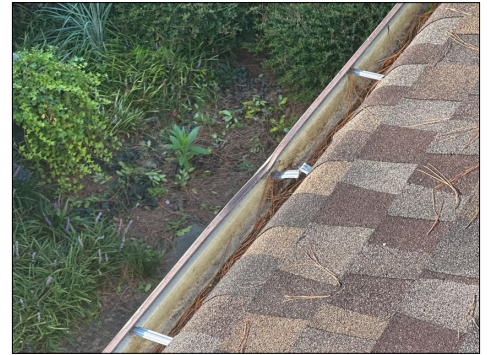
3.1. Gutters that were bent or damaged should be repaired as needed.

Bent gutters

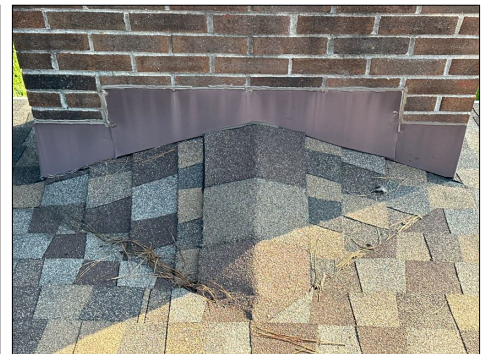
5.2. Sealant was used to prevent moisture intrusion. Sealants eventually dry, shrink and crack and can allow moisture intrusion. We cannot determine if sealant was added as an additional layer of protection or to cover an inadequate installation. Maintenance will be required to maintain sealant.

Sealant at flashing

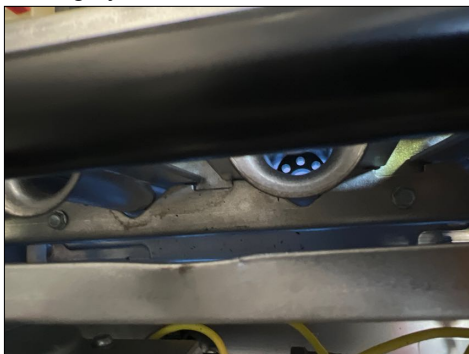
3.1. The heating system functioned. We recommend inquiring about the systems service record.

Functional

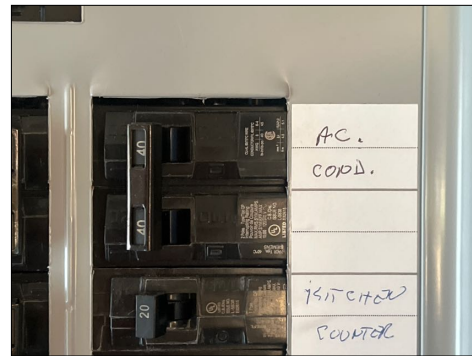
7.1. The breaker protecting the condenser exceeds the manufacturers listed maximum of 30 and should be corrected.

Oversized breaker

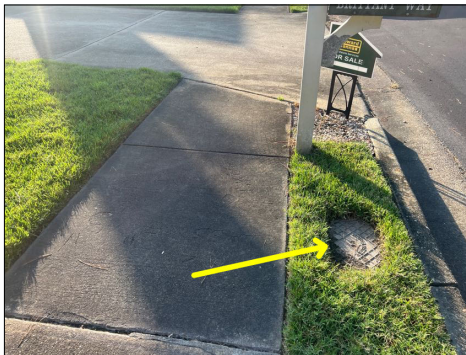
Water was publicly supplied and the main shutoff was located at the meter box below ground.

Shutoff underground at meter box

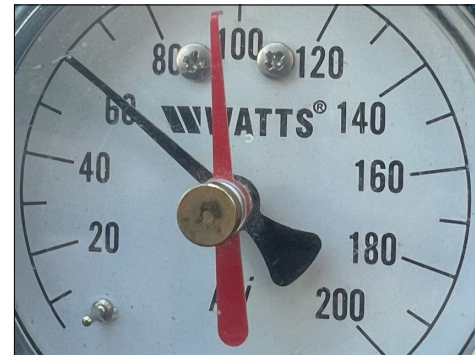
The water pressure was tested and was found to be within acceptable limits between 40 (PSI) and 80 PSI.

Good pressure between 40-80

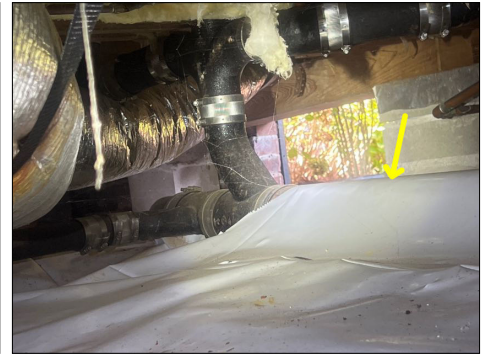
Cast iron under vapor barrier

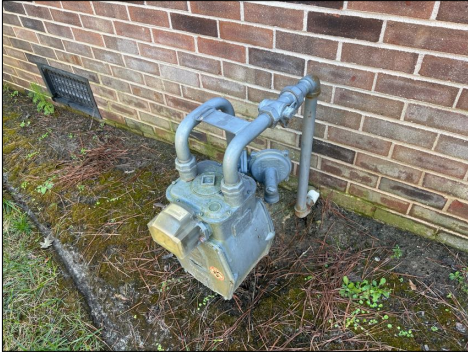
The **gas main** shut-off is located on the left side of the house.

Main Gas shutoff

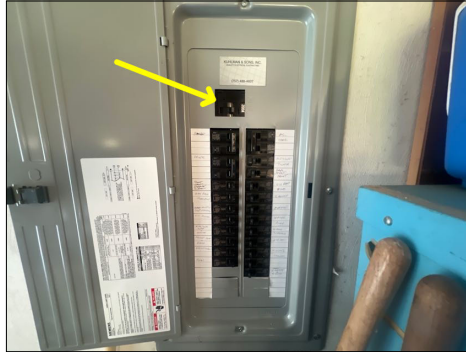
Service equipment rating was 200 amps.

Main disconnect - garage

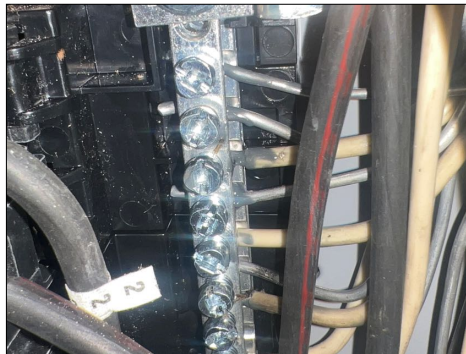
3.3. Solid aluminum (AL) branch circuit conductors were observed. You should ensure that a qualified electrical contractor has evaluated the aluminum wiring installation and made any needed corrections.

Branch circuit aluminum wiring

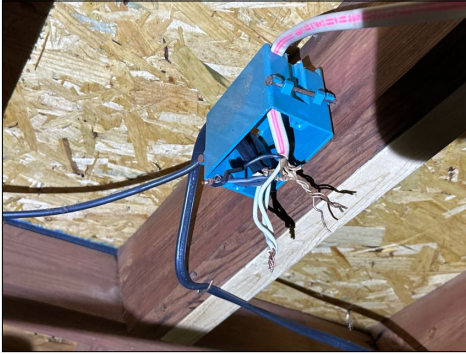
4.1. Open **junction boxes** should have covers installed. Location: middle and left attic

Junction boxes should have covers

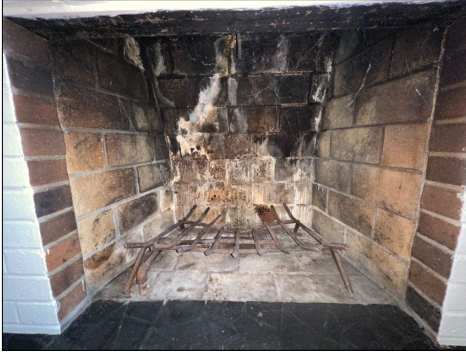
10.1. The firebox/flue was dirty and should be serviced as needed.

10.2. Rust and corrosion at the firebox indicates possible moisture intrusion should be serviced as needed.

Masonry wood burning fireplace

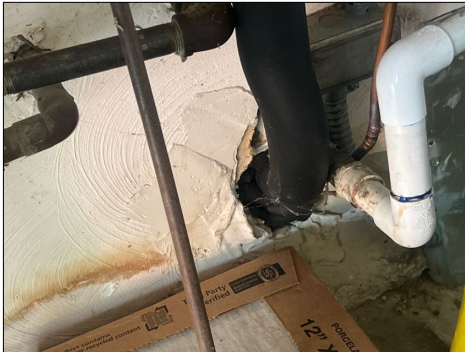
Separation wall penetration(s)

1.2. All garage separation wall penetrations should be appropriately repaired or sealed.

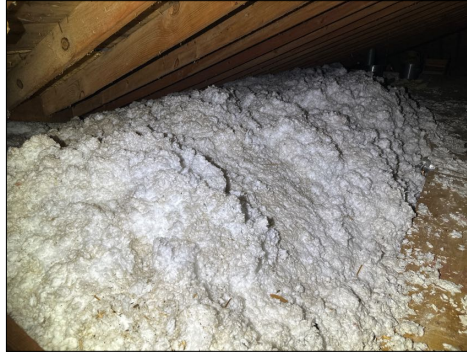
Loose fill fiberglass **attic insulation** was installed. Current standards for this area is 10"- 15" for approximately R-30 to R-38 insulating value. Adding additional insulation as an upgrade may improve the overall efficiency and comfort of the home, but it may take several years to pay back in terms of energy savings. You may wish to consult with a qualified contractor if the installed levels are a concern.

Approximately 15+ inches installed

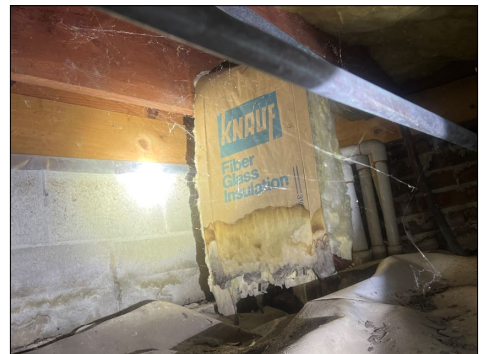
Falling insulation

- 2.1. Loose insulation should be repaired or replaced as needed.
- 2.2. Damaged and compromised insulation should be replaced where needed.
- 2.3. The source of **standing water** should be located and needed corrections made. Location: rear middle, and front right
- 2.4. The crawlspace vapor barrier does not fully cover the soil or has been rendered ineffective by damage and should be repaired as needed.

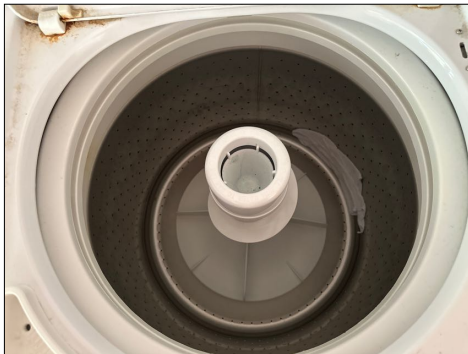
- 8.1. The washing machine was run through a short cycle. The washer filled with water, agitated, spun, and drained. This does not confirm how well the machine washes clothes, and not all settings were tested.
- 8.2. The data plate was missing, illegible, inaccessible or could not be located.

Drained

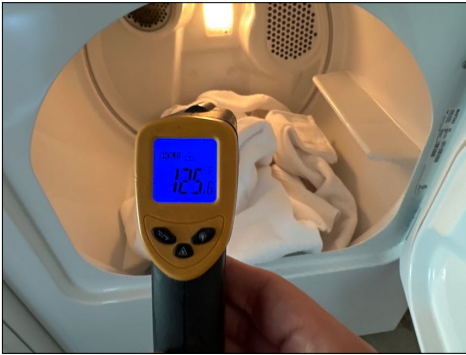
- 9.1. We ran the dryer through a short cycle to determine if it was functional. The dryer got hot, but we can not tell how well it dries clothes, and not all settings were tested.
- 9.2. FYI: A three prong 240 Volt electrical outlet was installed.

3 Prong outlet — Functional

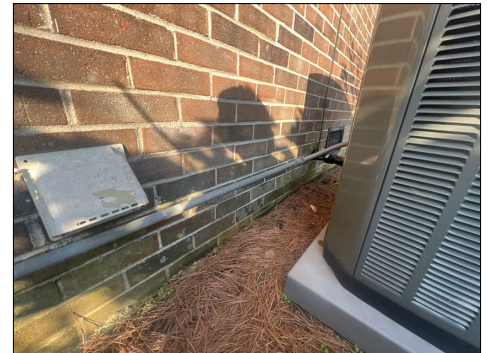
10.1. Improve: The dryer vented near the AC unit which may clog the fins affecting the systems' efficiency, and will likely require continual cleaning. Relocation of the vent is recommended.

Venting too close to condenser

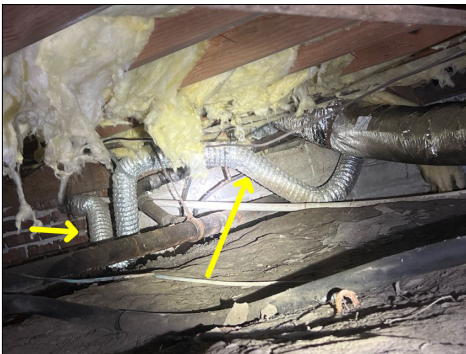
Transition duct in crawlspace

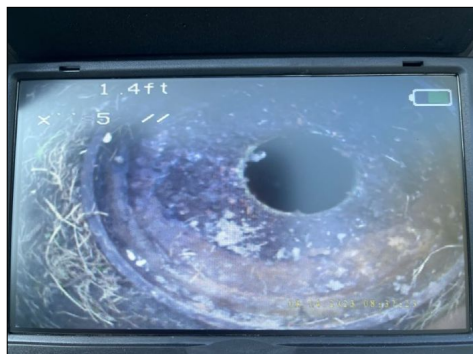
Cleanout

The sewer line was entered at the clean out located at: right side driveway

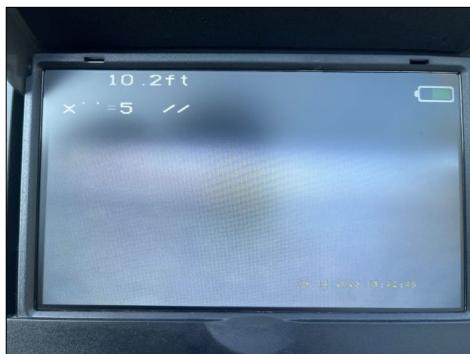
Approximately 10ft/ standing water

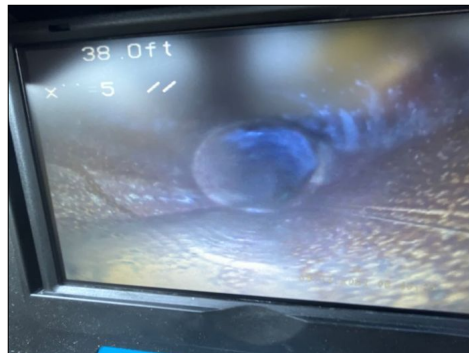
City Main

Slight oval shape to drain line
